Inspection Report
Minerals Regulatory Program
March 6, 2013

Mine Name: Unpermitted Operation near Antimony
Operator Name: Garfield County

Permit number: Unpermitted
Inspection Date: February 25, 2013
Time: 3:45-4:15 PM

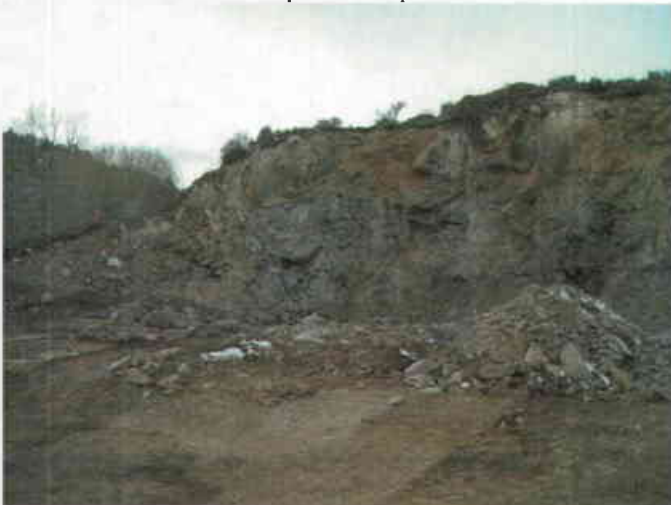
Photo 1

This area has been mined to extract rock for riprap along the East Fork of the Sevier River immediately adjacent to the quarry. Because the erosion control project and quarry are contiguous, it is very difficult to draw a line where the quarry ends and the stream restoration project begins, so I am unsure how many acres were disturbed by the mine and did not attempt to map the area. There is a highwall that I estimated to be about 30-40 feet high (Photos 1 and 2).

The contractor is nearly done with the project, and it is expected that reclamation will be completed by the end of April. Because three government entities are involved, I recommend that the Division obtain a Notice of Intention with associated maps but, assuming reclamation is completed as planned, not require a reclamation surety. The Division should continue to monitor the site for revegetation success.

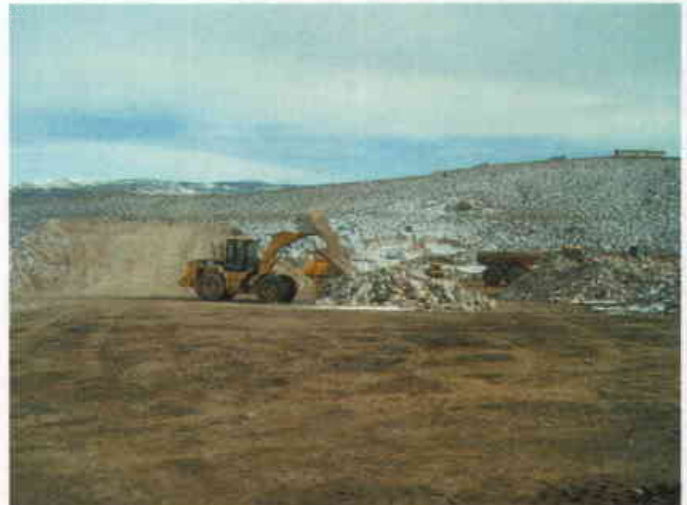
Photo 3

Rees Construction has been quarrying rock, using a grizzly to screen it (Photo 3), and putting material along the stream as part of a project for the Natural Resources Conservation Service in cooperation with the Division of Wildlife Resources.
